TITLE: Trial polishing

1. Flat Specimen Characteristic

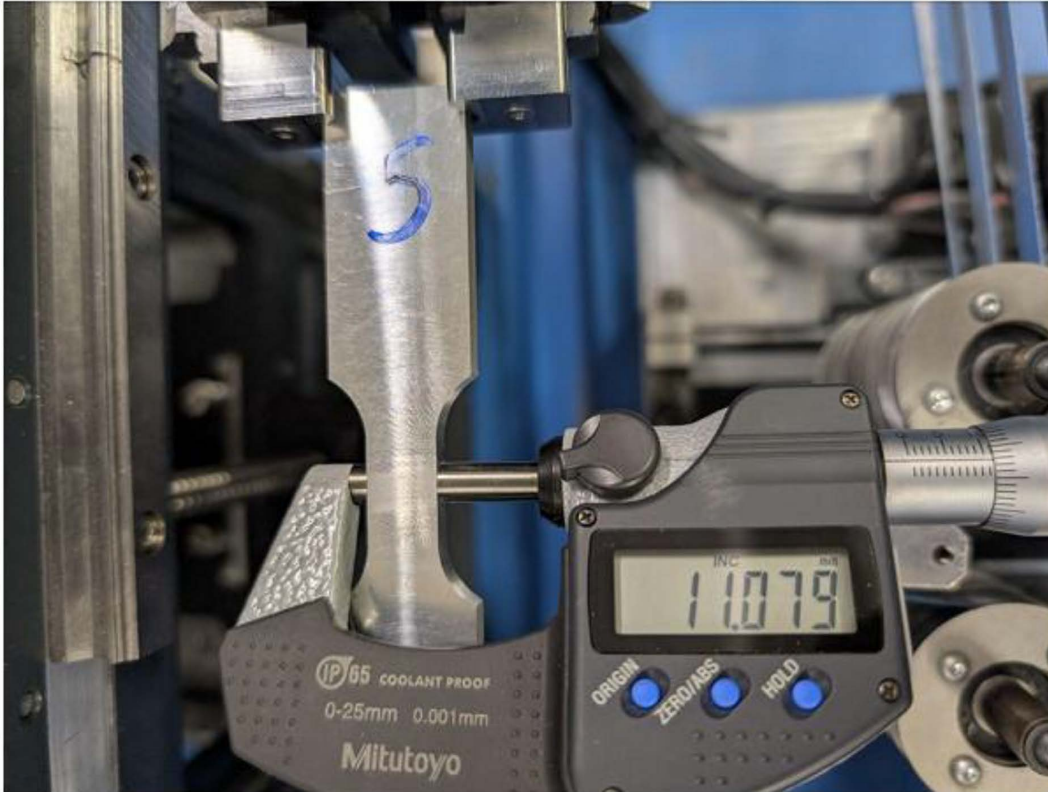
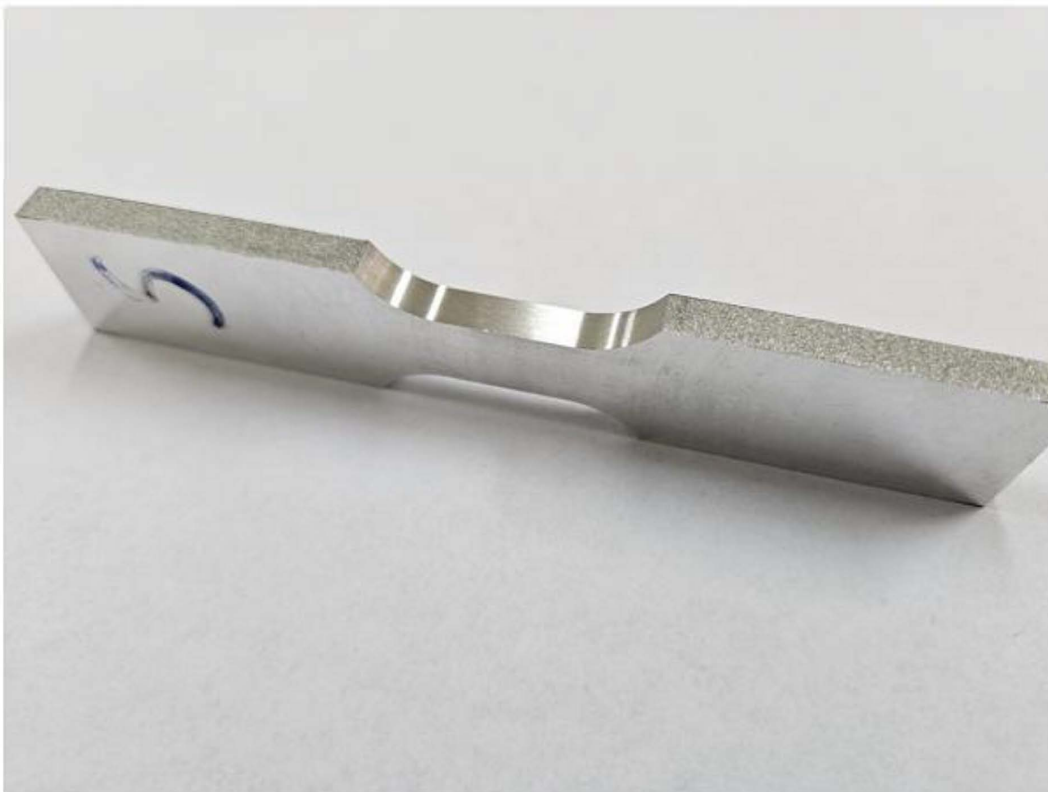
Pic.4. Specimen 5 after step 4 - 0.1mm removal

STEP 1 Sandpaper grit	P180
Contact Force	10 N
Polishing Speed	6000 mm/min
Polishing cycles per side	25

STEP 2 Sandpaper grit	P600
Contact Force	10 N
Polishing Speed	6000 mm/min
Polishing cycles per side	40

STEP 3 Sandpaper grit	P1200
Contact Force	10 N
Polishing Speed	6000 mm/min
Polishing cycles per side	120

STEP 4 Sandpaper grit	P2000
Contact Force	10 N
Polishing Speed	6000 mm/min
Polishing cycles per side	120

Ad.6. "Material Removal - Remove the final 0.025 mm by polishing longitudinally to impart a maximum of 0.2 μm surface roughness." - 0.025mm came out definitely too little. After 0.07 mm cavities were still visible so we decided to polish further and somewhere about 0.1 mm cavities started to disappear.

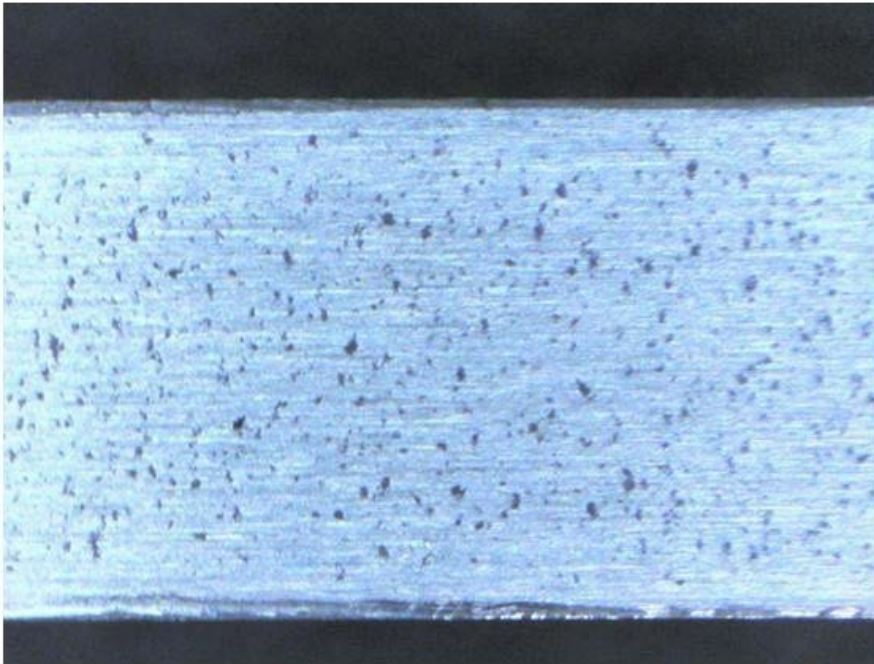
Pic.8. Specimen 8 surface after removal of 0.04mm - microscope photo

Specimen 8 was polished only 0.04 mm to show the cavities left

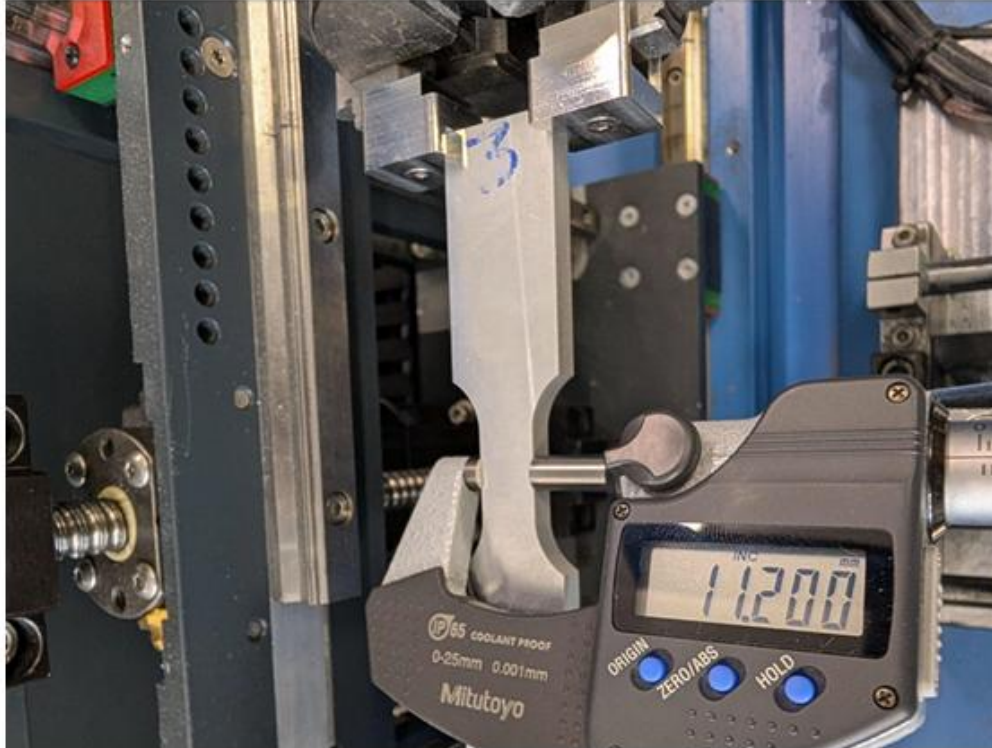
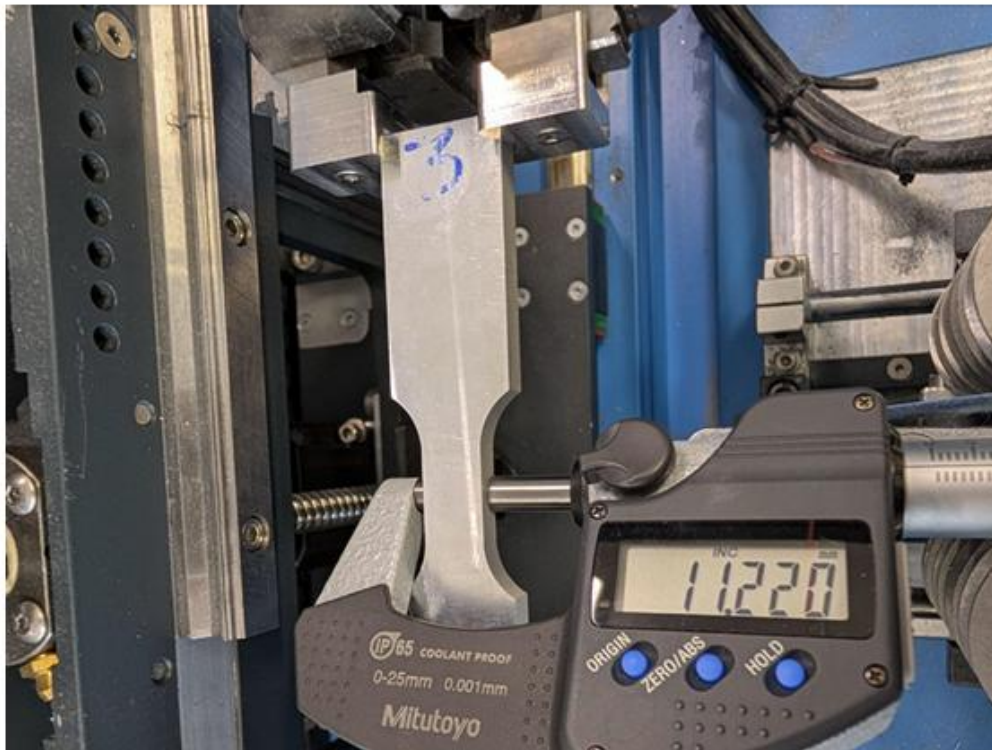
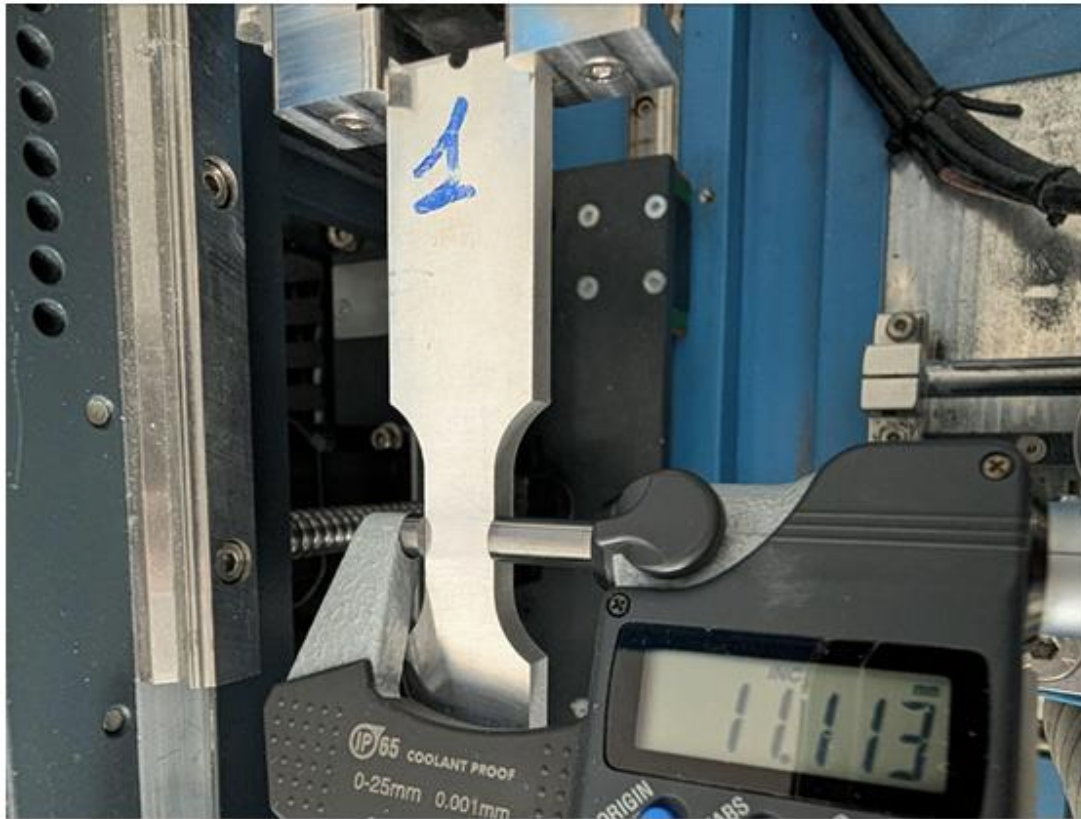
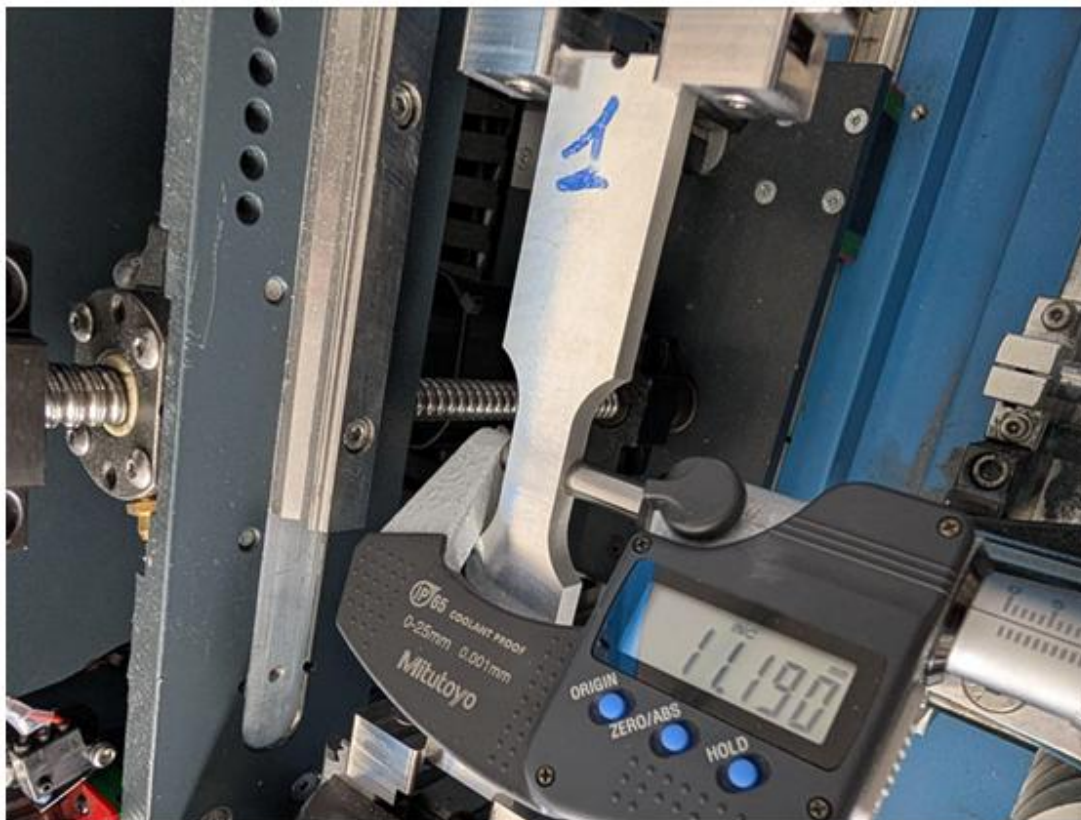
4.1. Specimens 1, 2, 3, 4, 7 had slightly inclined cut surfaces before starting the polishing process – see the photos below.
